Level I Contamination Screening Evaluation Report

MALABAR ROAD PD&E STUDY

From St. Johns Heritage Parkway to Minton Road

Project No. 23773

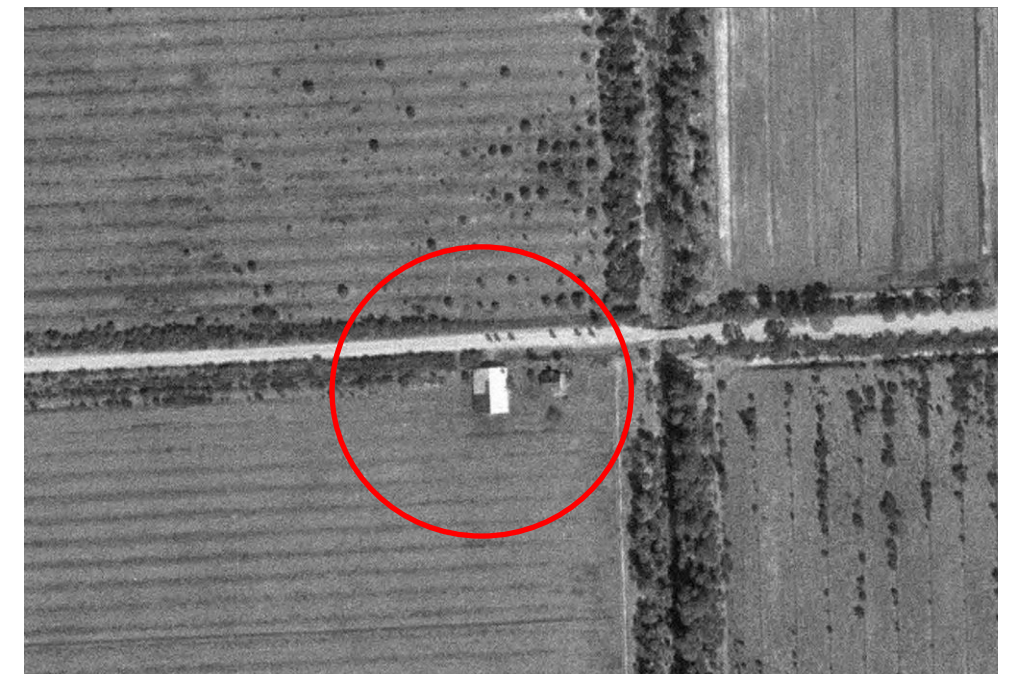
SITE OBSERVATIONS: The site is currently vacant land with overgrown vegetation. The barn appears to have been demolished due to weather or manually. Aluminum roofing materials and wooden planks are visible in piles along the northern portion of the site.

Photo taken from 1972 historical aerial showing agricultural barn.

CONCLUSIONS: Based on the agricultural use of this site, the location of Flood Plain Compensation Area (FPCA) and Pond C-7 Alt 2, and its proximity to Malabar Road, this site has been assigned a CRR of **Medium**.

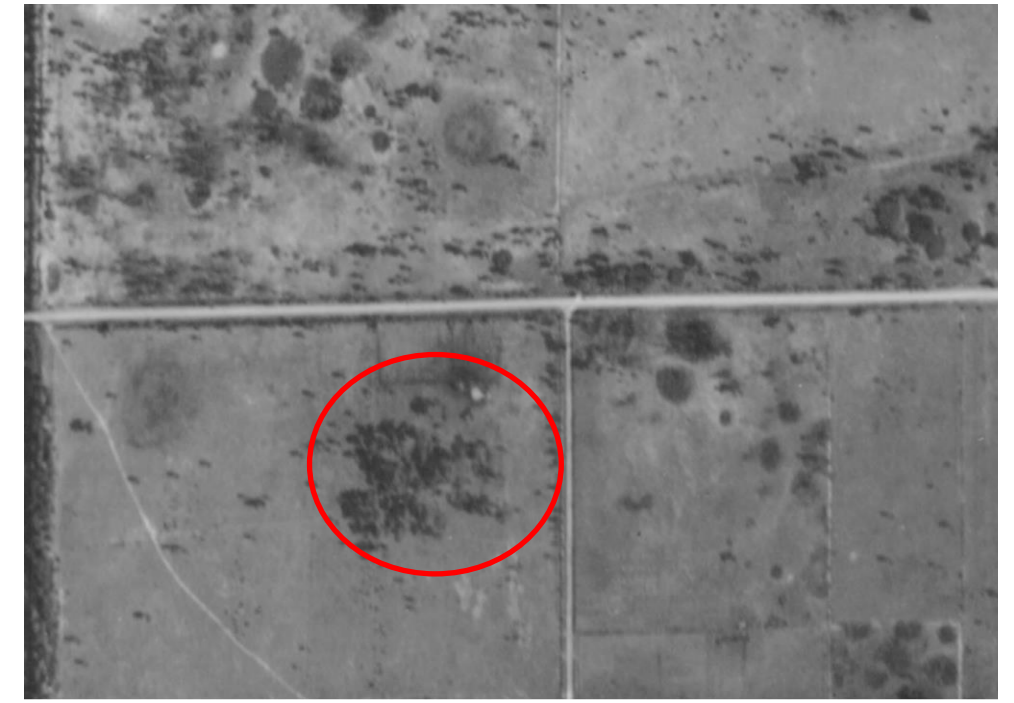
Site No:	3		Risk Potential:	MEDIUM	
Site Name	Cattle Pen				
Site Address	Malabar Road				
Site Location	Southwest quadrant of the Malabar Road and Allison Drive Intersection				
Distance/Direction	Station: 98+80 Offset: 60' Right				
Facility ID Nos:	N/A				
Database Listings/Sources:	Historical Aerial Photograph Review				
Historical Land Use	Agricultural/Cattle Pen				
Current Land Use	Vacant Land				
Contaminants	Hazardous Materials				
TANKS	U/A	Capacity (gal)	Content	Installed	Removed
N/A	N/A	N/A	N/A	N/A	N/A
Discharge Date	N/A		Cleanup Date:	N/A	
	Soil		Groundwater		
Documented/ Known Impacts:	NO		NO

SITE OBSERVATIONS: The site was difficult to see due to overgrown vegetation and dense woods. No evidence of a cattle pen was found on site.

CONCLUSIONS: Based on the potential for residual pesticide impacts at this site, and its proximity to Malabar Road, this site has been assigned a CRR of **Medium**.

Photo taken from 1943 historical aerial showing the cattle pen.

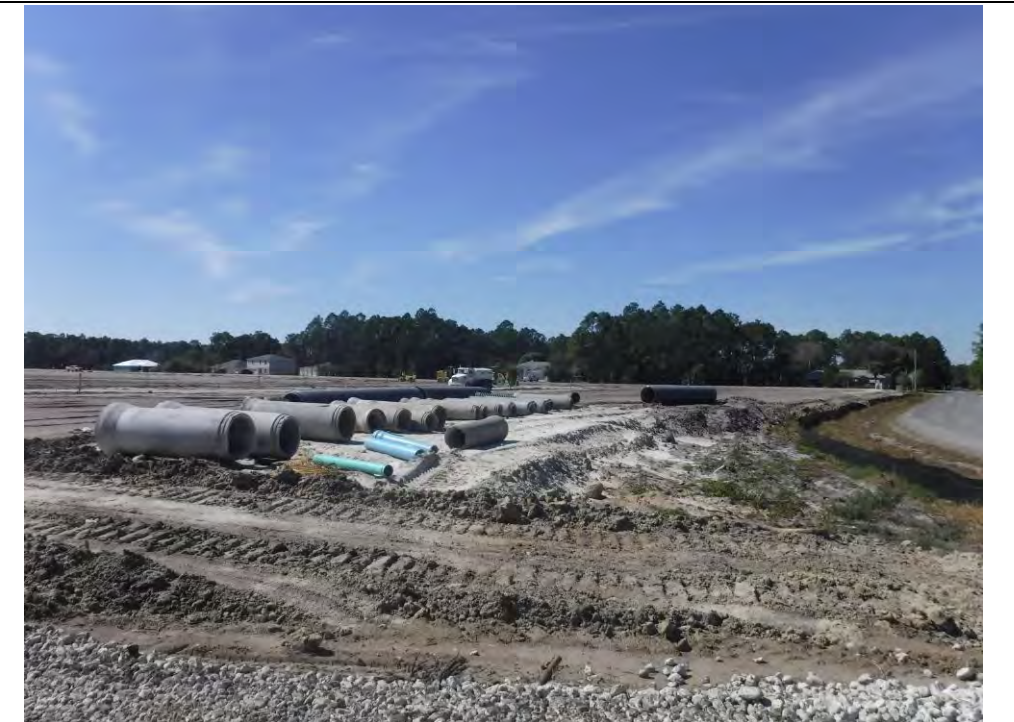
SITE OBSERVATIONS: The site has been cleared and appears to be under construction.

Photo taken from north of the site facing south. The area is under construction and currently contains concrete and PVC pipes.

CONCLUSIONS: Based on the lack of contamination records and its distance from the roadway widening project, this site has been assigned a CRR of **Low**.

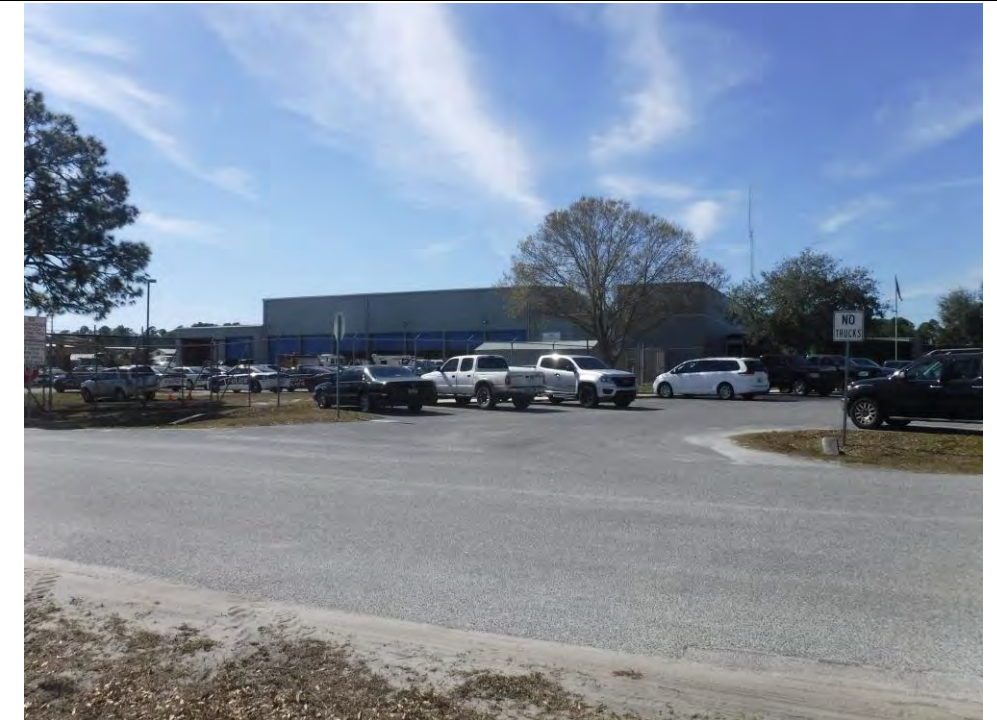
SITE OBSERVATIONS: The site is currently the City of Palm Bay Public Works facility.

Photo taken from north of the site facing south. The Public Works building and parking area are visible.

CONCLUSIONS: Based on the distance (the fueling tanks are > 400 feet south of Malabar Road) of the facility from the roadway widening activities, and the SRCO issued for the site in January 2014, the site has been issued a CRR of **Low**.

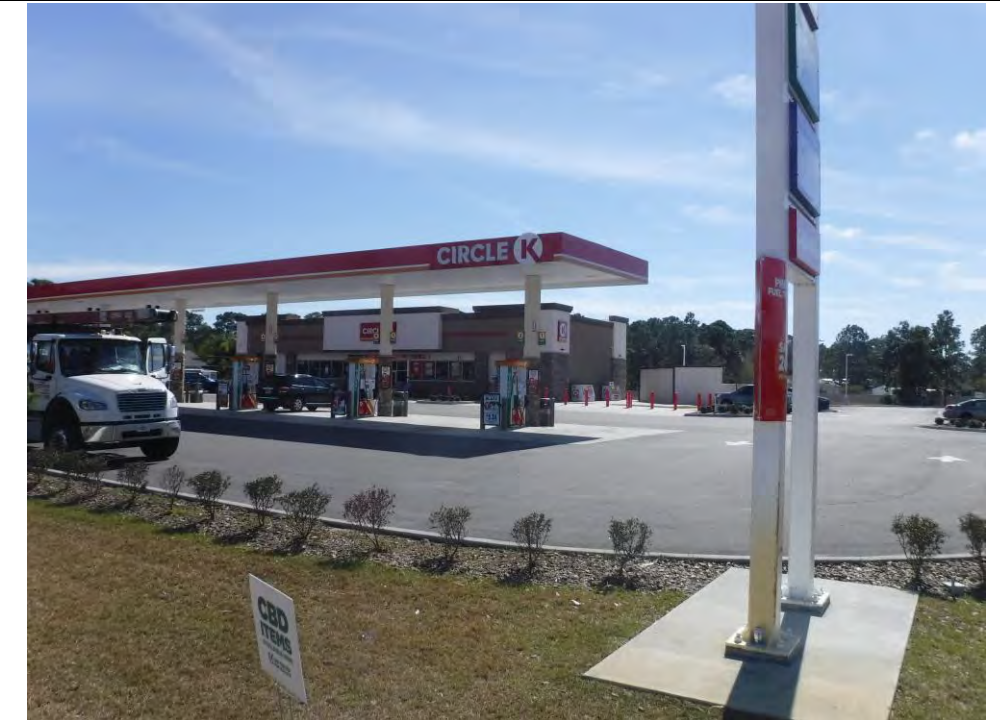
SITE OBSERVATIONS: The site is currently a Circle K gas station.

Photo taken from north of the site facing south. The Circle K gas station is visible.

CONCLUSIONS: Based on the site's proximity to Malabar Road, the projects roadway widening and re-alignment, and the gas station nature of the property, this site has been assigned a CRR of **Medium**.

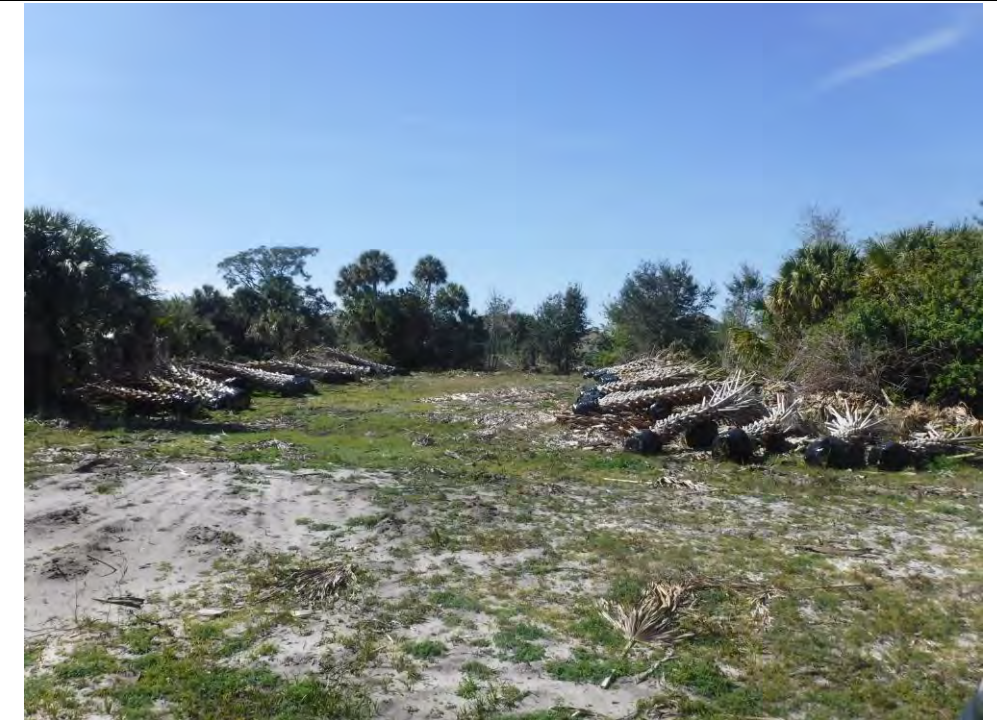
CONCLUSIONS: Based on the footprint of the C-20 Alternative 2 pond, and the known arsenic plume, this site has been assigned a CRR of **Medium**.

Photo taken from north of the site facing south. Large unplanted palm trees are visible across the vacant site.

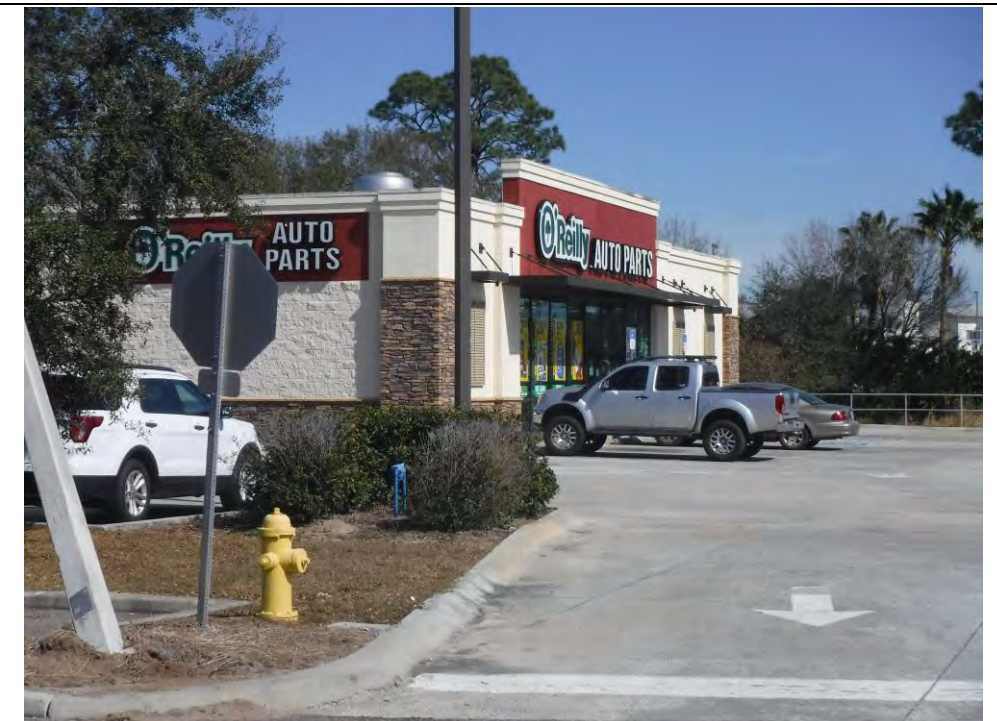
SITE OBSERVATIONS: The site is currently an O'Reilly Auto Parts.

Photo taken from west of the site facing east. The O'Reilly Auto Parts store is visible.

CONCLUSIONS: Based on the lack of documented contamination impacts, and no observable signs of contamination during the site reconnaissance, this site has been assigned a CRR of **Low**.

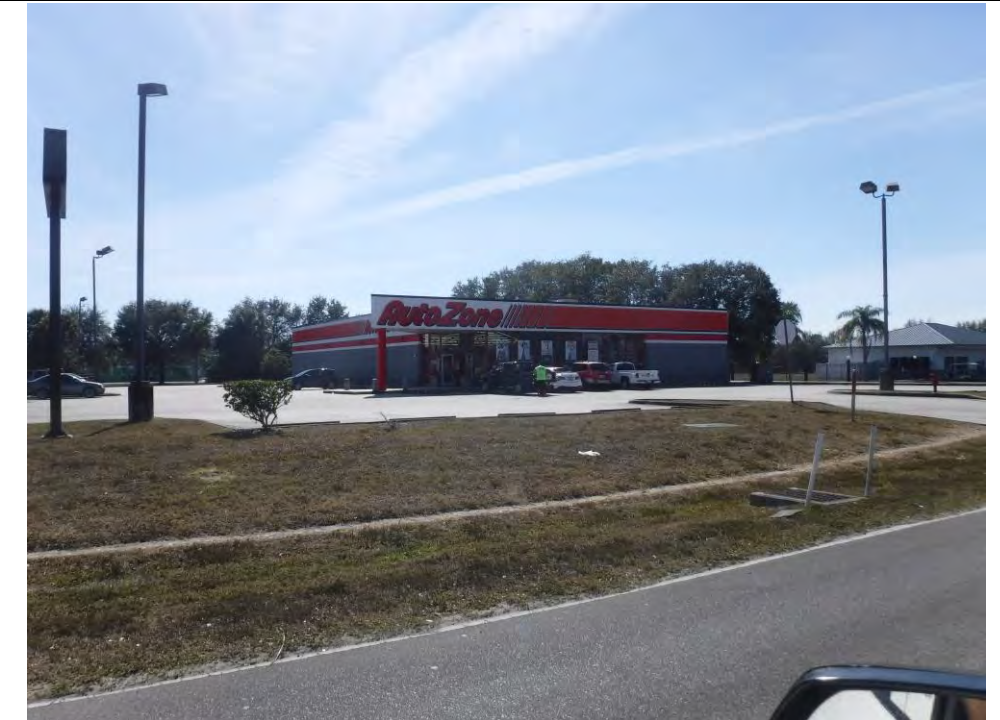
CONCLUSIONS: Based on the lack of documented contamination impacts, and no observable signs of contamination during the site reconnaissance, this site has been assigned a CRR of **Low**.

Photo taken from north of the site facing south. The Auto Zone is visible.

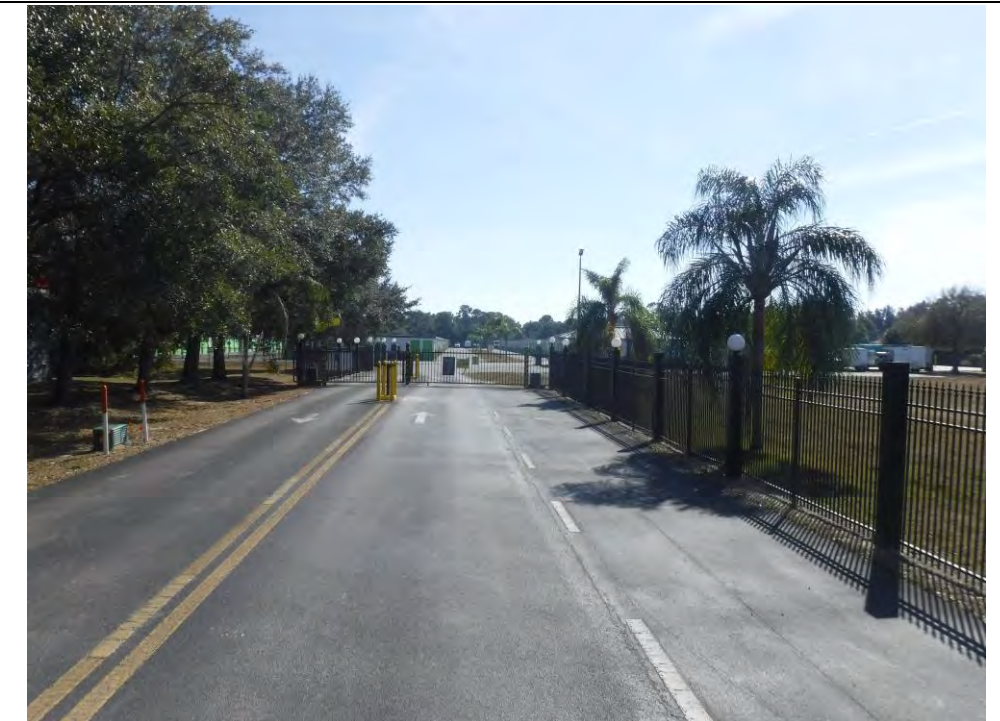
Site No:	10		Risk Potential:	LOW		
Site Name	Coastal Biosystem					
Site Address	270 Malabar Road					
Site Location	South of Malabar Road					
Distance/Direction	Station: 257+00 Offset: 450' Right					
Facility ID Nos:	FLR0000089342					
Database Listings/Sources:	RCRA NonGen / NLR, FINDS, ECHO, City Directories					
Historical Land Use	Citrus Grove					
Current Land Use	Storage Facility					
Contaminants	Hazardous Materials					
TANKS	U/A	Capacity (gal)	Content	Installed	Removed	
N/A	N/A	N/A	N/A	N/A	N/A	
Discharge Date	N/A		Cleanup Date:	N/A		
	Soil			Groundwater		
Documented/ Known Impacts:	NO			NO

CONCLUSIONS: Based on the closed hazardous waste status, the lack of documented contamination impacts, and the site's location outside of the stormwater pond footprint, this site has been assigned a CRR of **Low**.

Photo taken from north of the site facing south. Coastal Biosystem is visible.

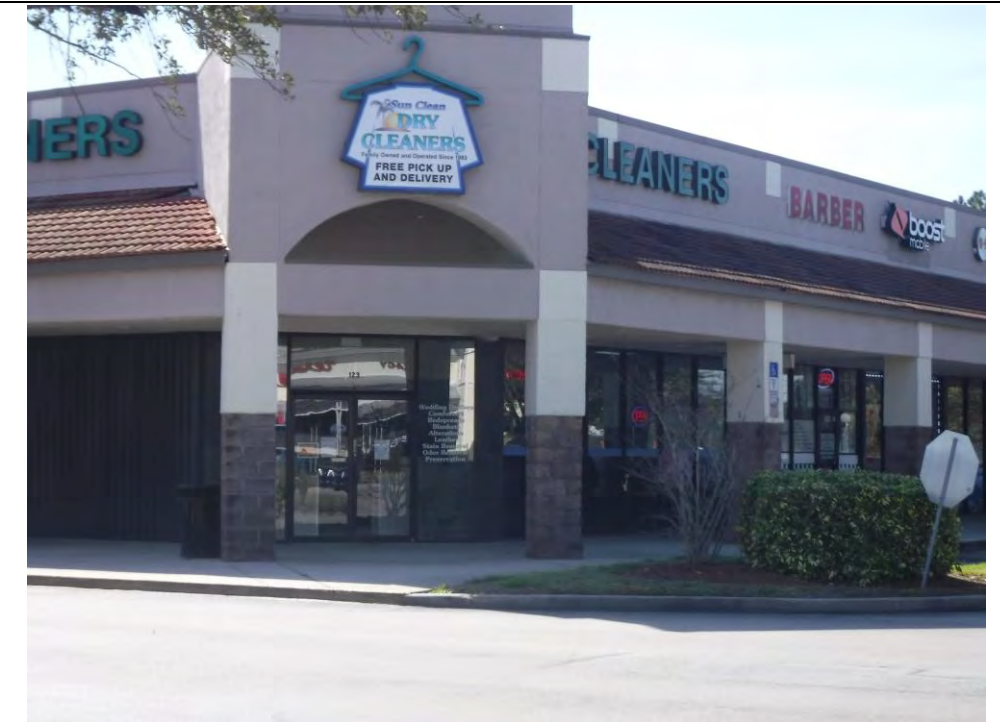
PUBLIC RECORDS: The site is listed as a dry-cleaning facility from 1995 through 2017. A tank facility registration number was issued and no record of any registered tanks or documented contamination impacts were found.

CONCLUSIONS: Based on the lack of documented contamination impacts, the site has been issued a CRR of **Low**.

Photo taken from northeast of the site facing southwest. The Sun Clean Dry Cleaners is visible.

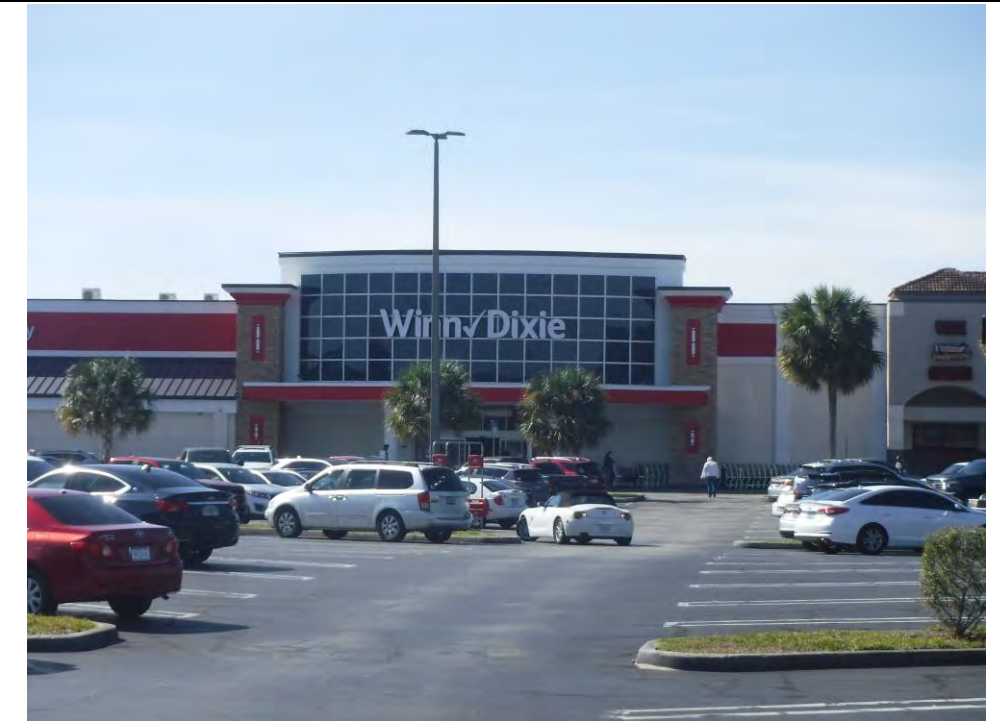
SITE OBSERVATIONS: The site is currently a Winn-Dixie grocery store.

Photo taken of the site while facing west. The Winn-Dixie Store is visible.

CONCLUSIONS: Based on the lack of contamination impacts and its distance from the Malabar Road widening, the site has been issued a CRR of **Low**.

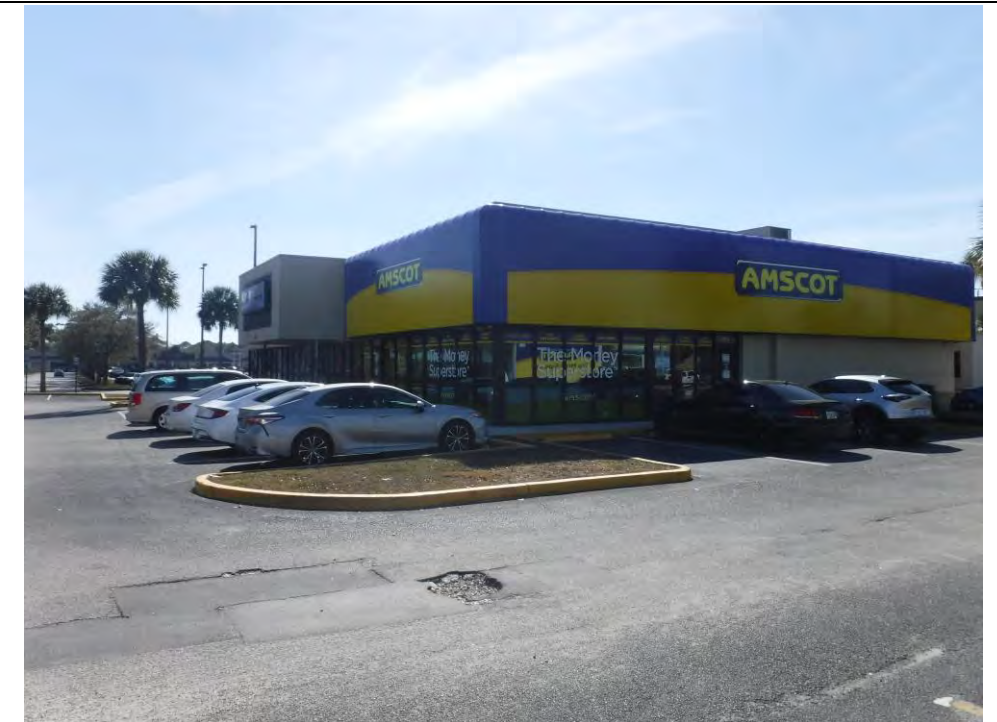
SITE OBSERVATIONS: The site was formerly an auto supply shop. It currently is an Amcscot loan office.

Photo taken from southeast of the site facing northwest. An Amcscot is visible.

CONCLUSIONS: Based on the lack of documented contamination impacts and the site being located outside of the footprint of a stormwater pond, this site has been assigned a CRR of **Low**.

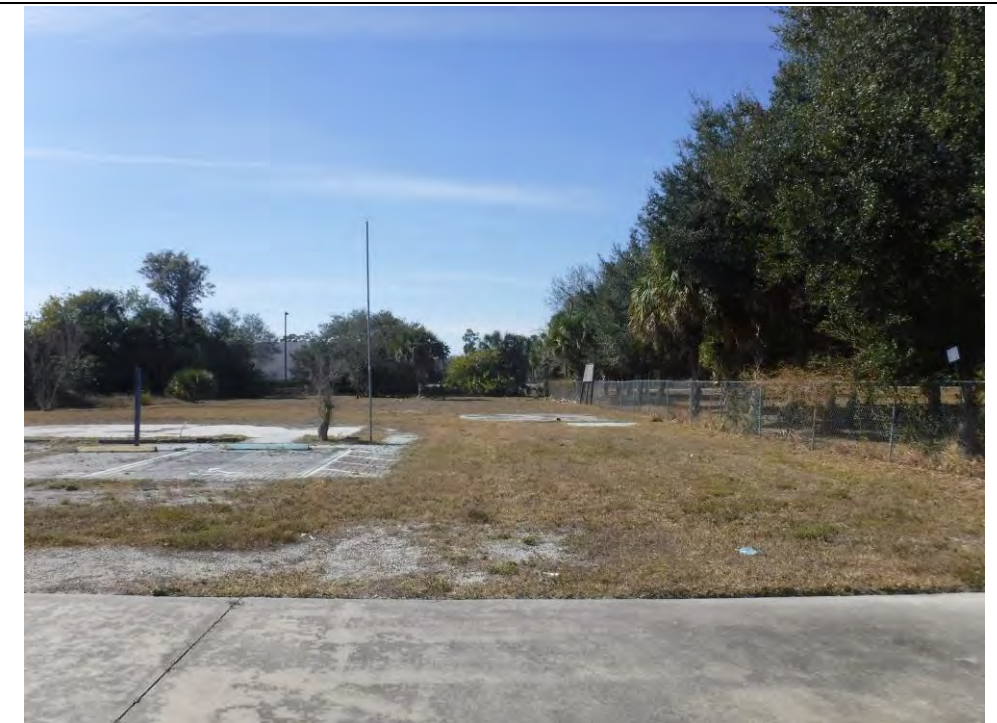
SITE OBSERVATIONS: The property has been cleared. Concrete slabs are visible along with de-energized power boxes.

Photo taken from east of the site facing west. The site appears to be vacant.

CONCLUSIONS: Based on the unknown locations of the aboveground tanks and lack of contamination assessments, the site has been issued a CRR of **Medium**.

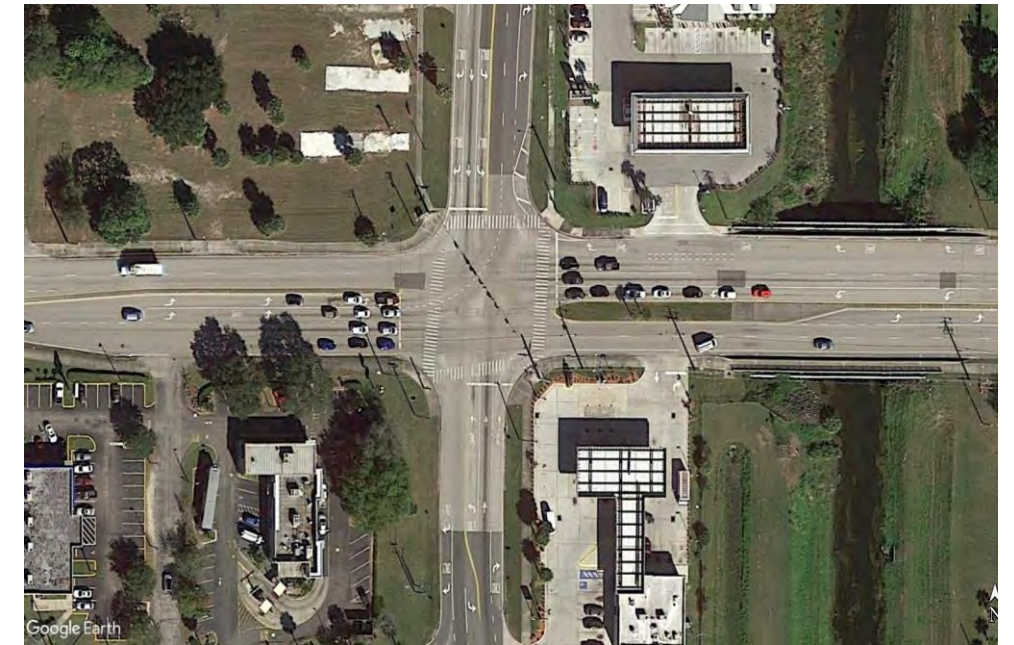
Photo taken from a 2020 aerial photograph showing the intersection of Malabar Road and Minton Road.

CONCLUSIONS: Based on the lack of documented contamination impacts and the documentation provided by Mr. Gibbs stating no petroleum was released during the incident, this site has been assigned a CRR of **Low**.

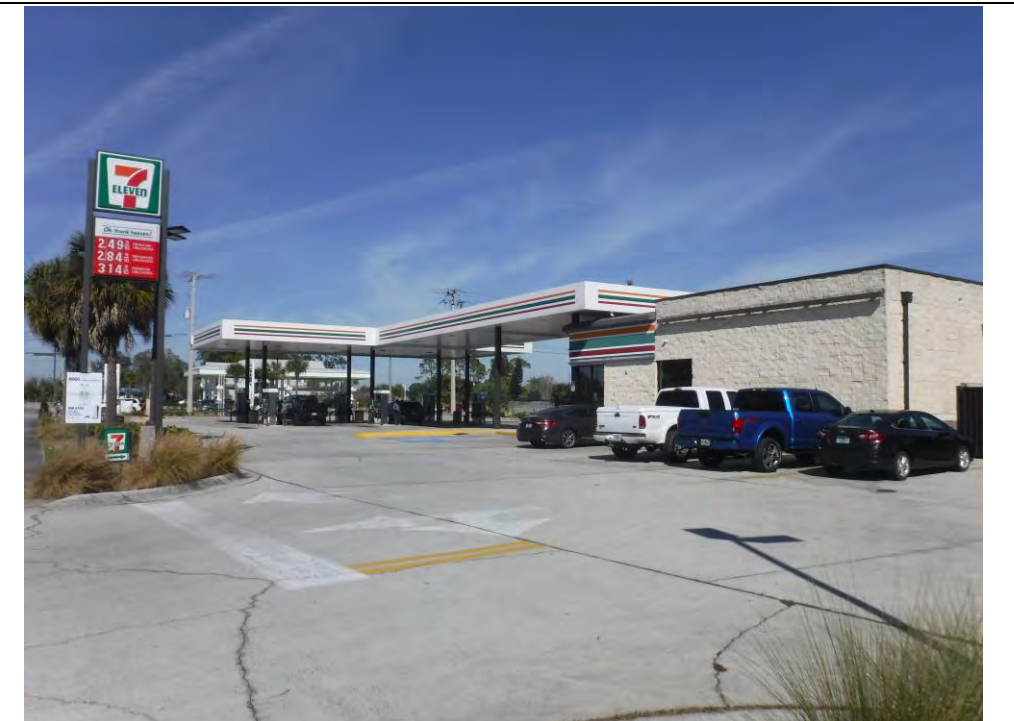
SITE OBSERVATIONS: The site is currently a 7-Eleven gas station.

Photo taken from southwest of the site facing northeast. The 7-Eleven gas station is visible.

CONCLUSIONS: Based on the site's proximity to Malabar Road, and the known soil and groundwater contamination at the property, this site has been assigned a CRR of **Medium**.

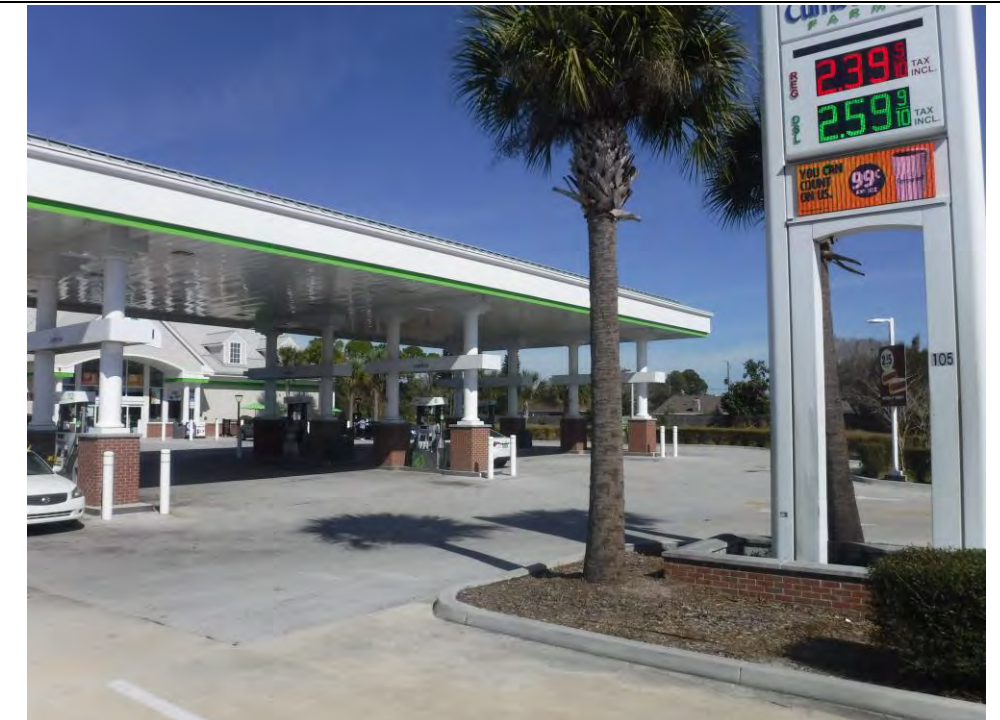
SITE OBSERVATIONS: The site is currently a Cumberland Farms gas station.

Photo taken from southwest of the property facing northeast. The Cumberland Farms gas station is visible.

CONCLUSIONS: Based on the site's proximity to Malabar Road and the gas station use of the property, this site has been assigned a CRR of **Medium**.

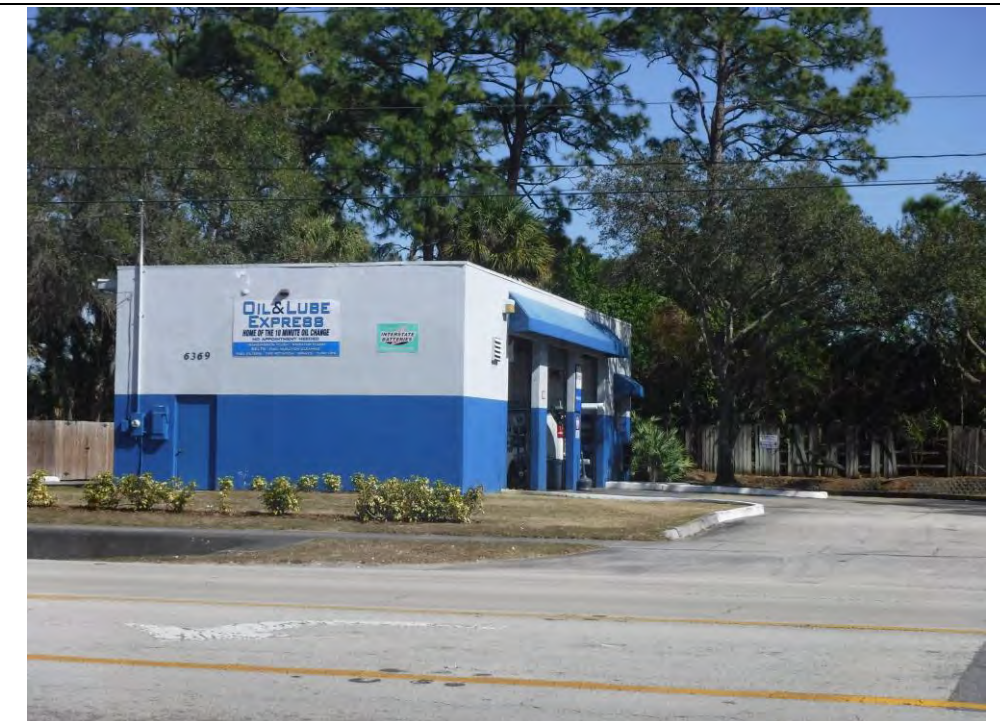
SITE OBSERVATIONS: The site is an active auto service center.

Photo taken from west of the property facing east. The Oil & Lube Center is visible.

CONCLUSIONS: Based on the lack of documented contamination impacts and the distance from Malabar Road to the site, this site has been assigned a CRR of **Low**.

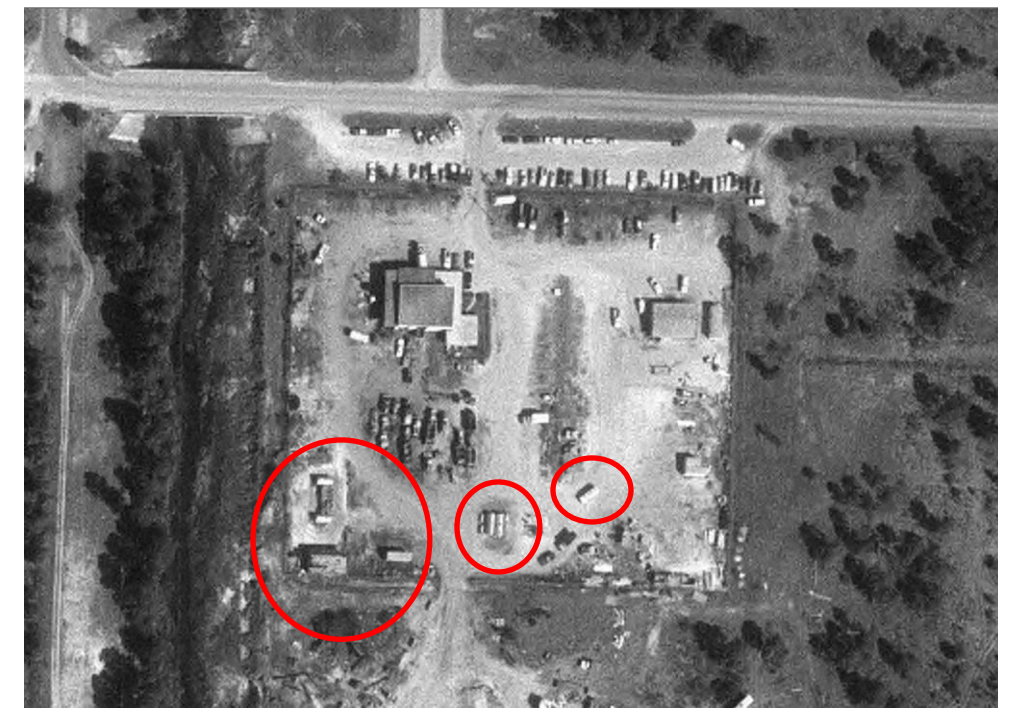
SITE OBSERVATIONS: The site is currently a stormwater pond directly adjacent to the Palm Bay City Hall.

Photo taken from 1980 historical aerial showing the construction yard and apparent fueling area and tanks are circled in red.

CONCLUSIONS: Based on a lack of documented contamination impacts and the location of the site on the east side of the canal at Minton Road outside of the Malabar Road alignment construction area, this site has been assigned a CRR of **Low**.

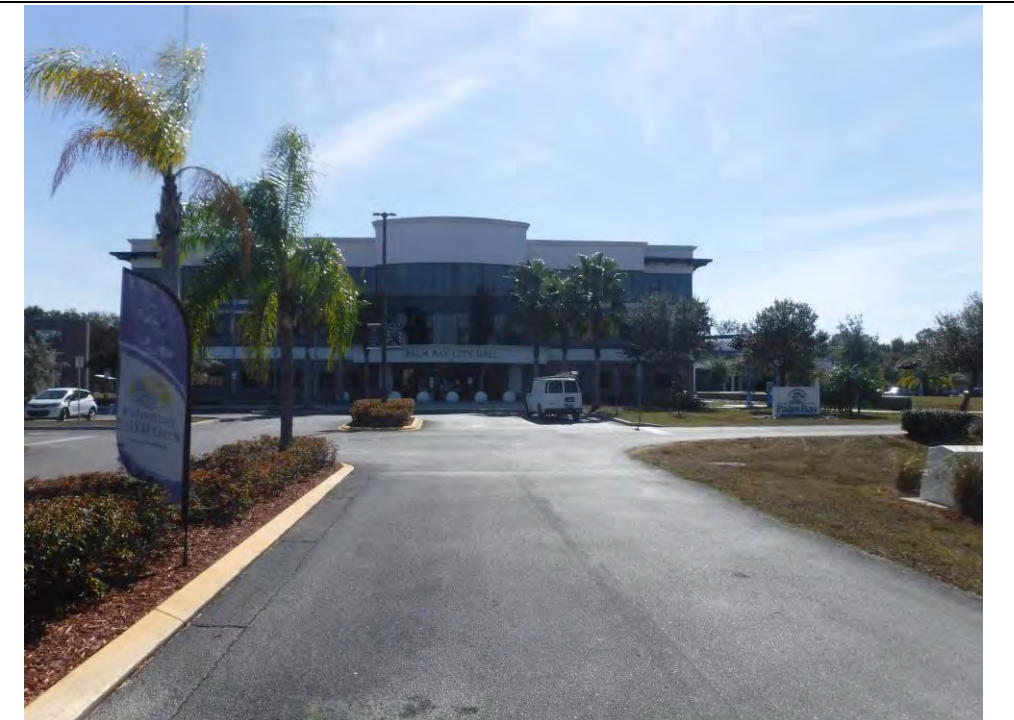
SITE OBSERVATIONS: The site is currently the Palm Bay City Hall.

Photo taken from northeast of the site facing southwest. The Palm Bay City Hall is visible.

CONCLUSIONS: Based on the location of the site on the east side of the canal at Minton Road, outside of the Malabar Road construction area but inside the 500-foot study area, and a lack of documented contamination impacts on-site, this site has been assigned a CRR of **Low**.

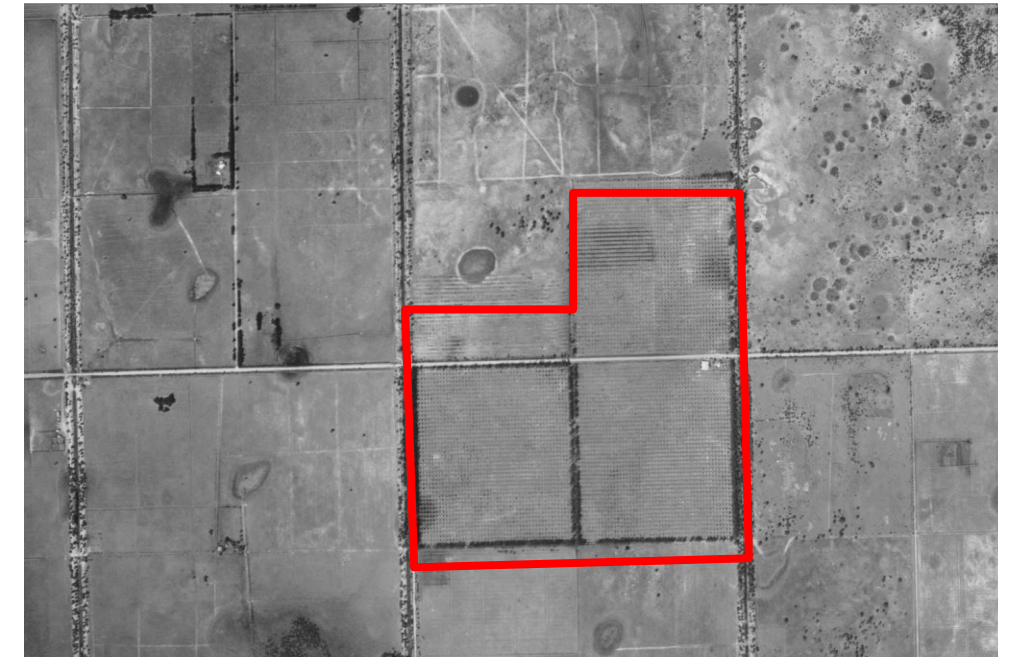
SITE OBSERVATIONS: During the site reconnaissance, no citrus grove locations were visible within the study area. The locations of the historical citrus groves are currently vacant land or were developed with residential and commercial properties.

Photo taken from 1951 historical aerial. Historical Citrus is visible.

CONCLUSIONS: Based on the historical citrus groves being within the footprint of several proposed stormwater ponds, this site has been assigned a CRR of **Medium**.

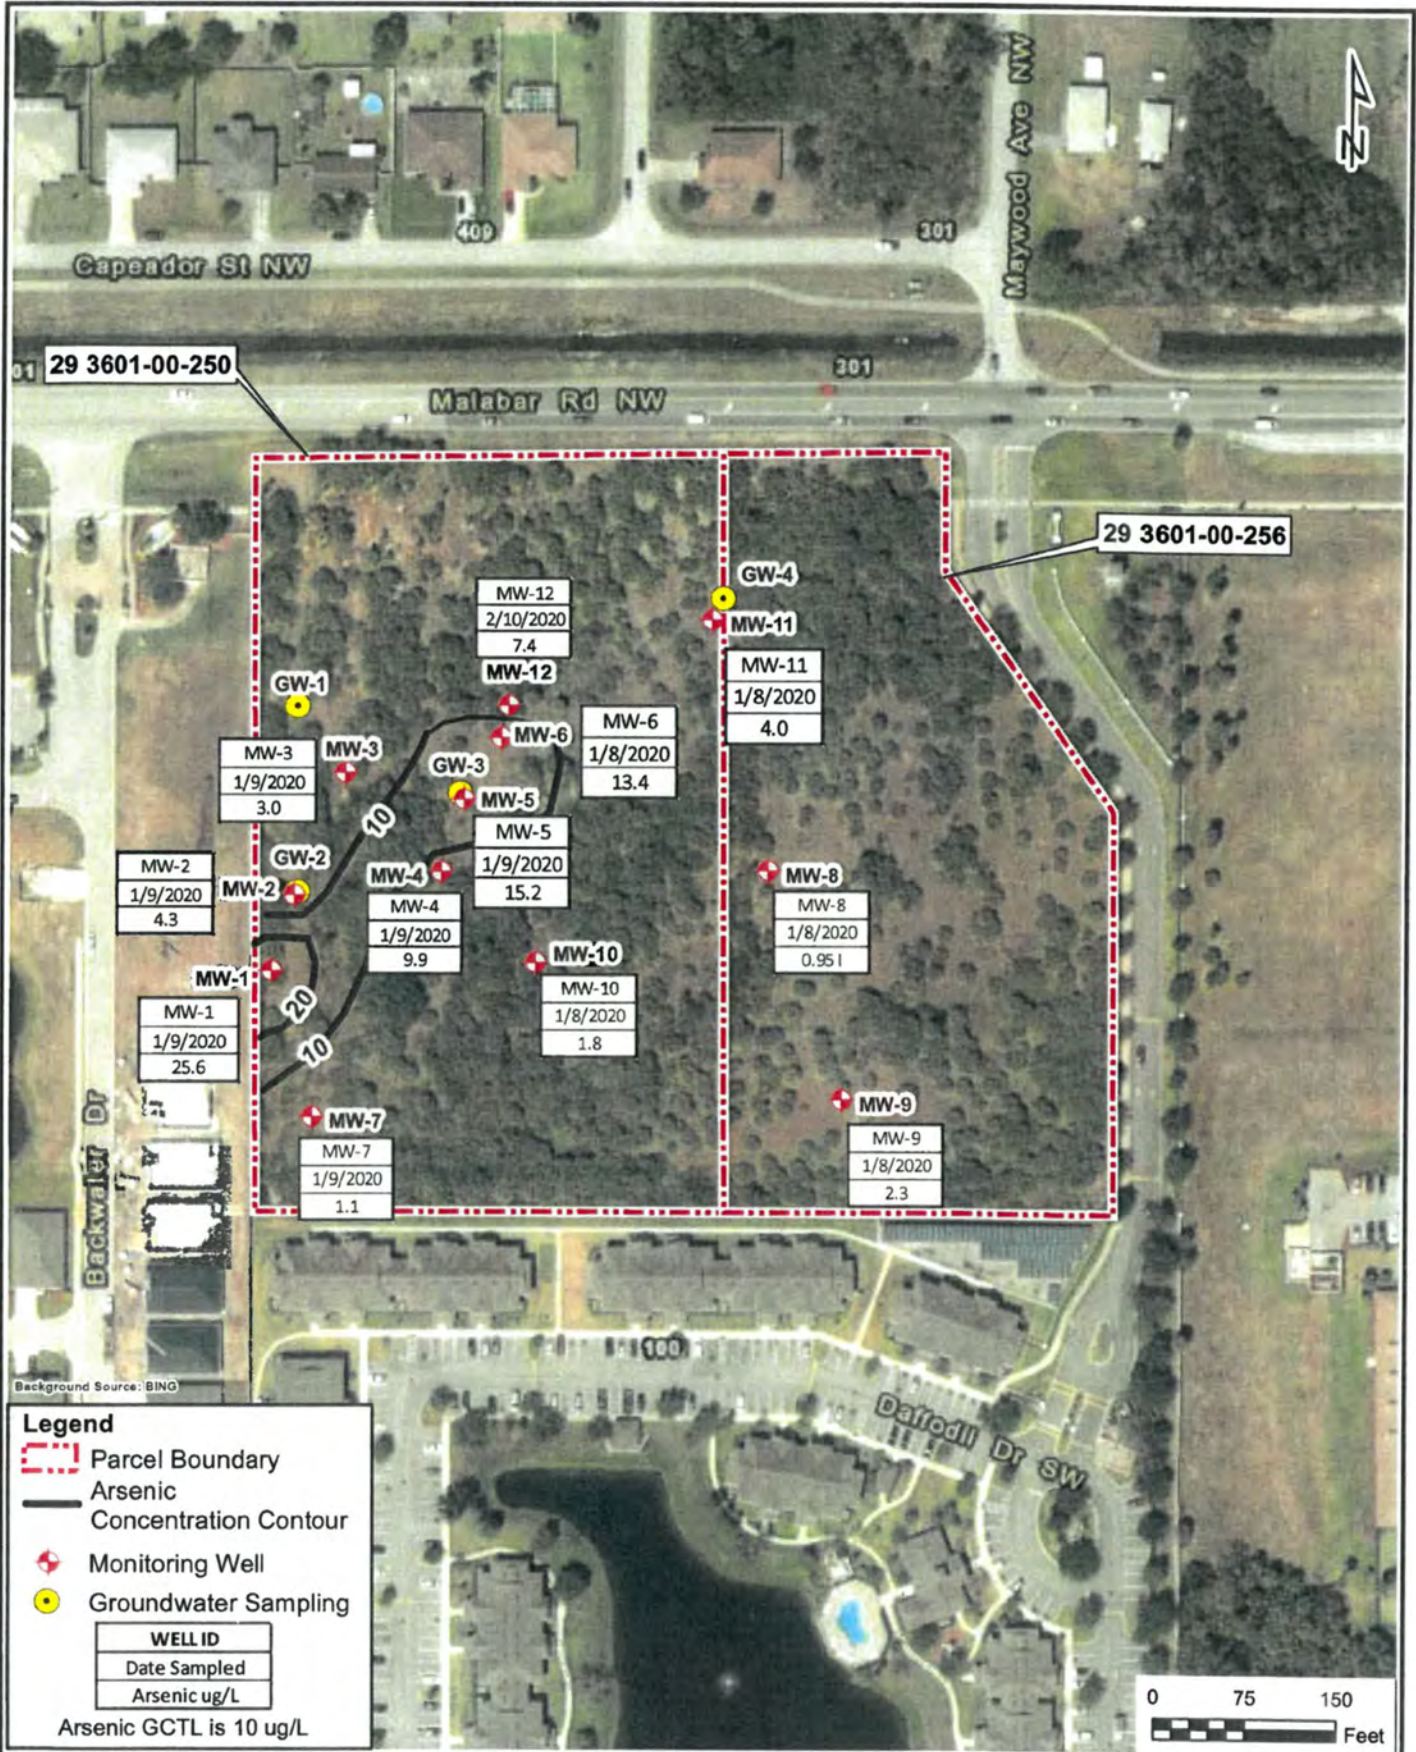
Attachments: Figure 1 "Groundwater Analytical Map (Arsenic ug/L)"
ODBS April 3, 2020 Memorandum

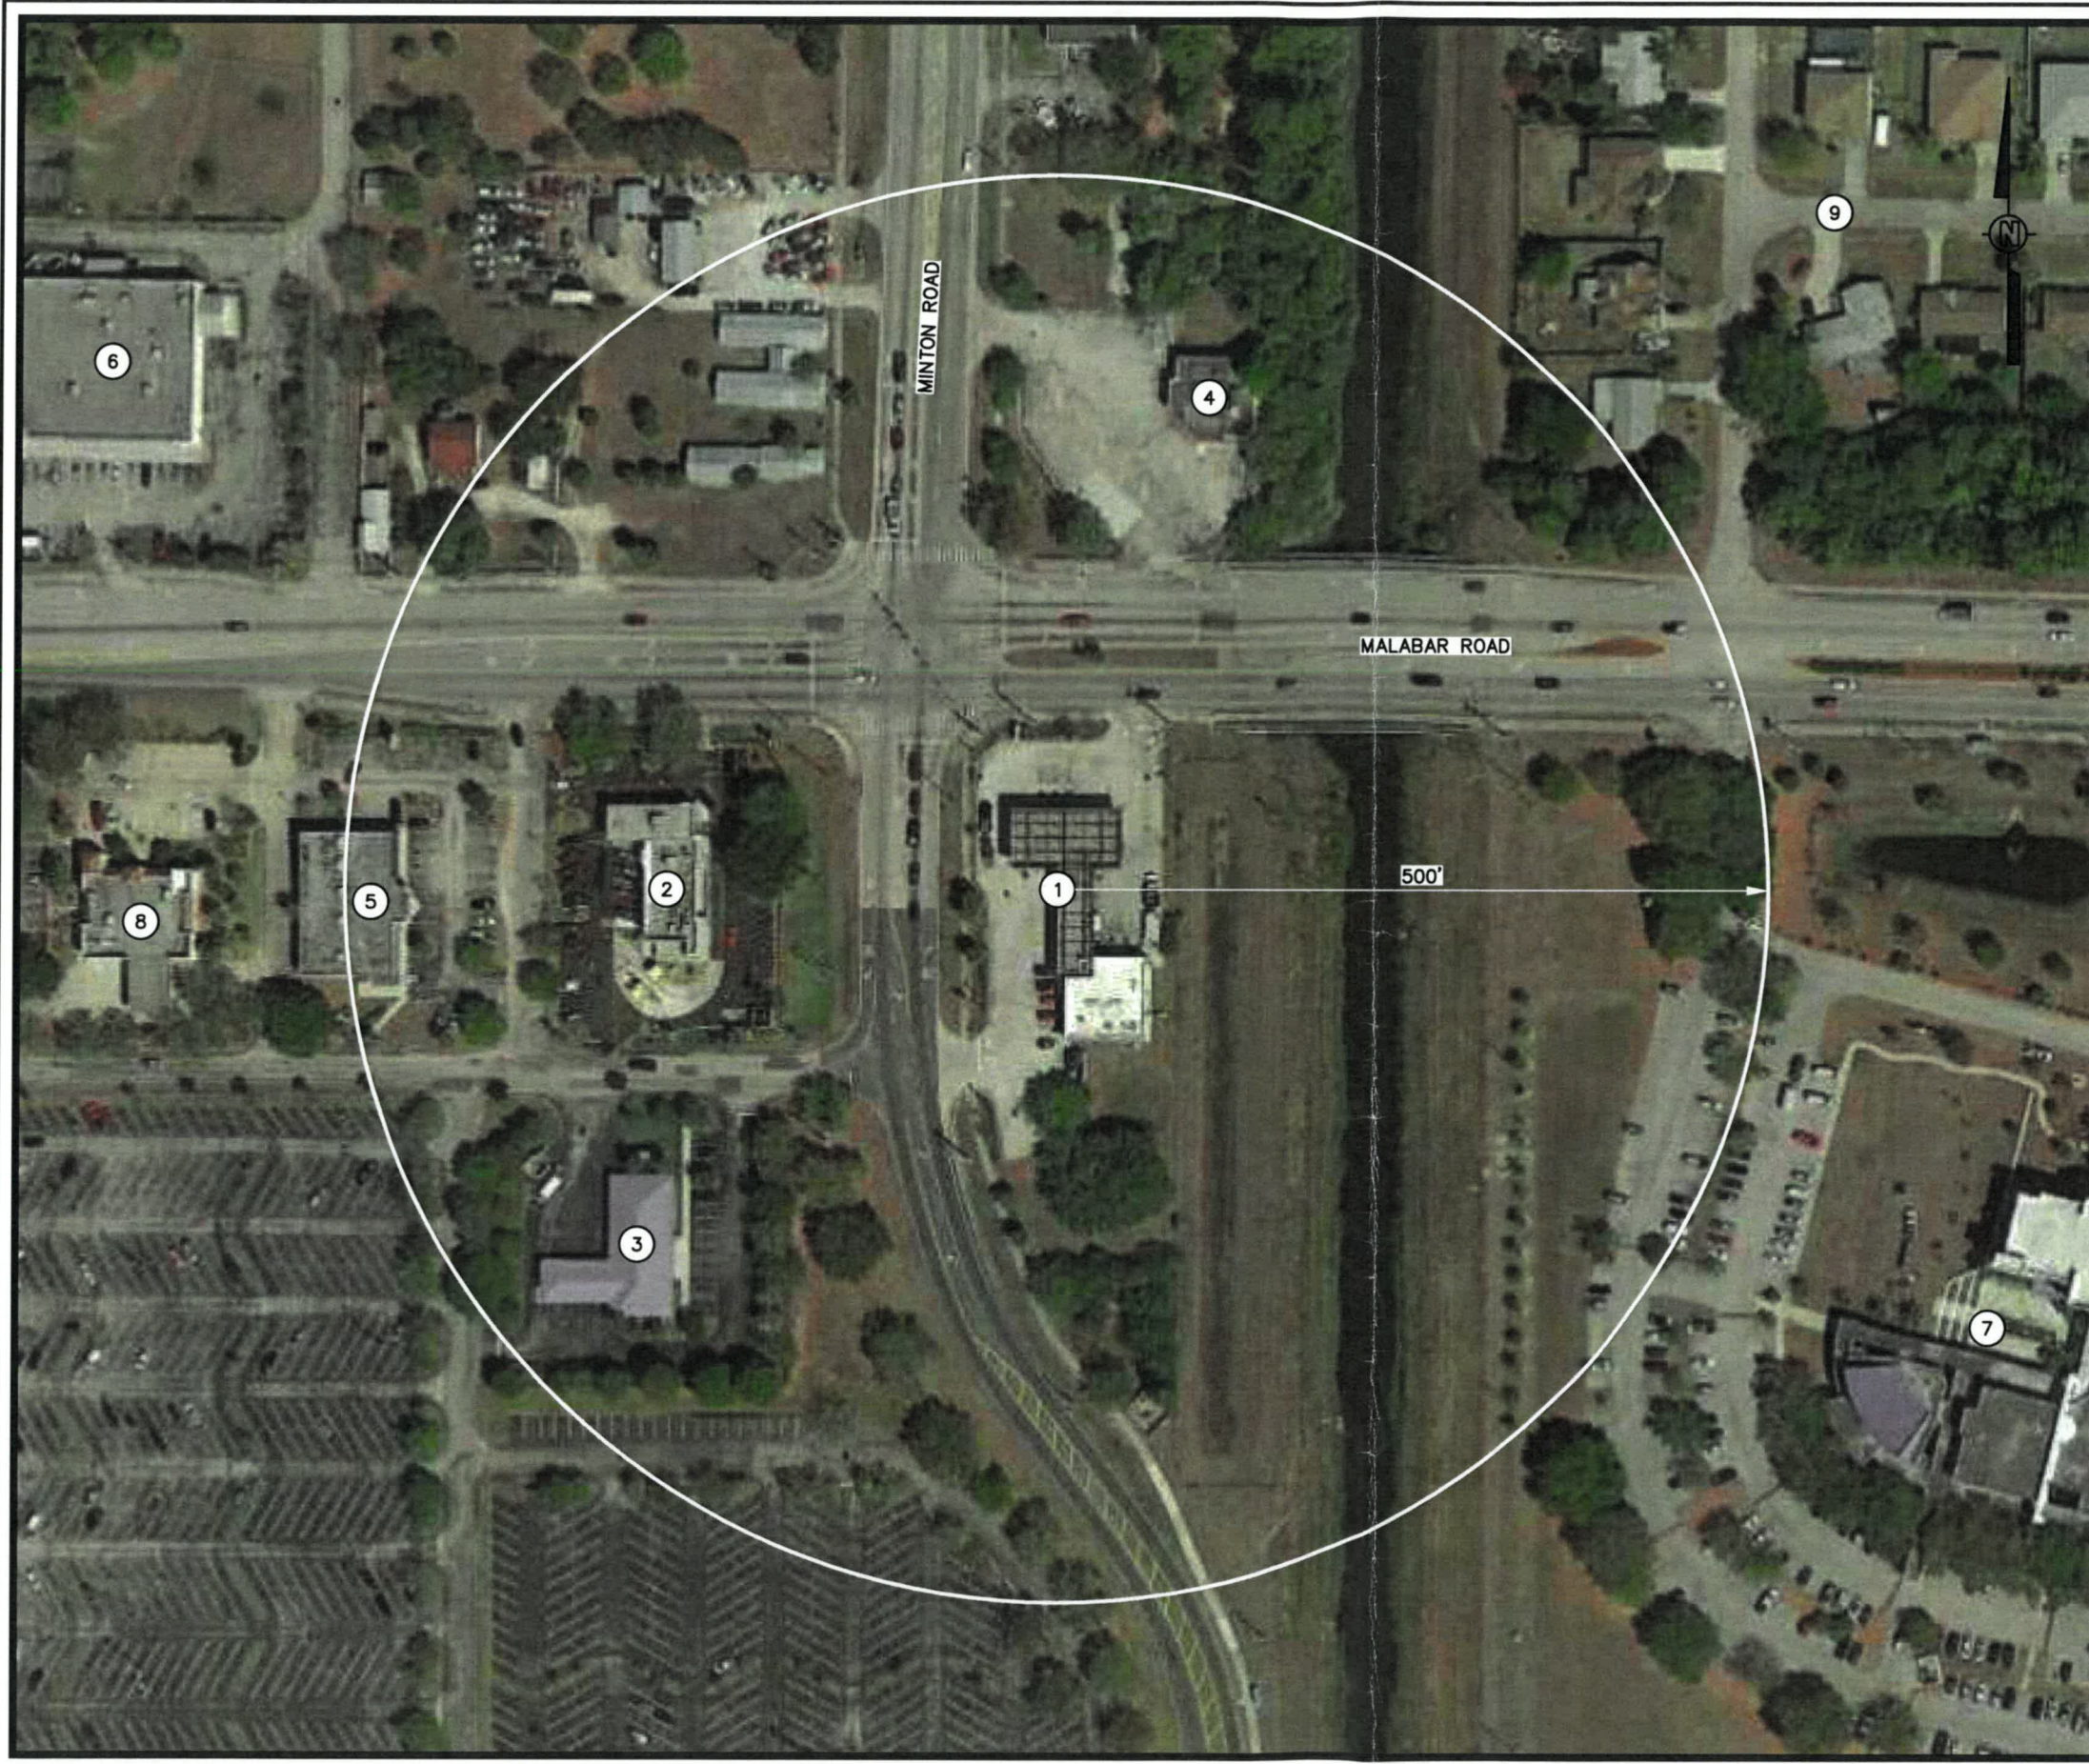
DESIGNED: DR	DRAWN: SDJF	PROJECT NO.: 631832002504	FIGURE: 3
-----------------	----------------	------------------------------	--------------

APTIM utilized the FDOH EHWATER website database to search for nearby petroleum or dry-cleaning facilities within a ½-mile radius around the site. The search listed one (1) site within ½-mile radius. Sites are listed on **Table 1** and depicted on **Figure 3**.
