Level I Contamination Screening Evaluation Report

MALABAR ROAD PD&E STUDY

From St. Johns Heritage Parkway to Minton Road

Project No. 23773

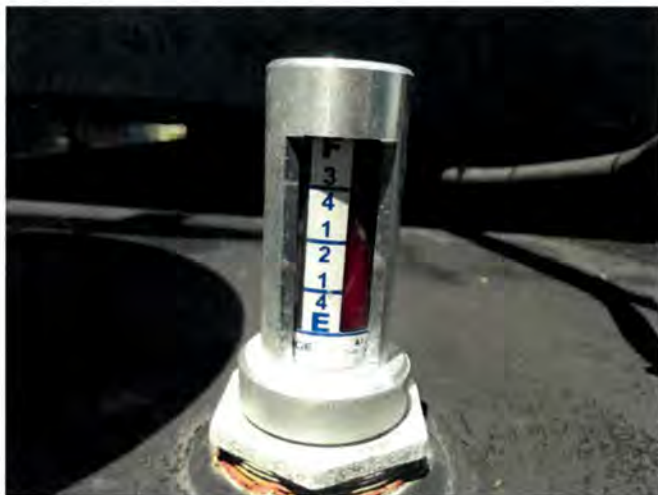
capacity gauge showing tank is full

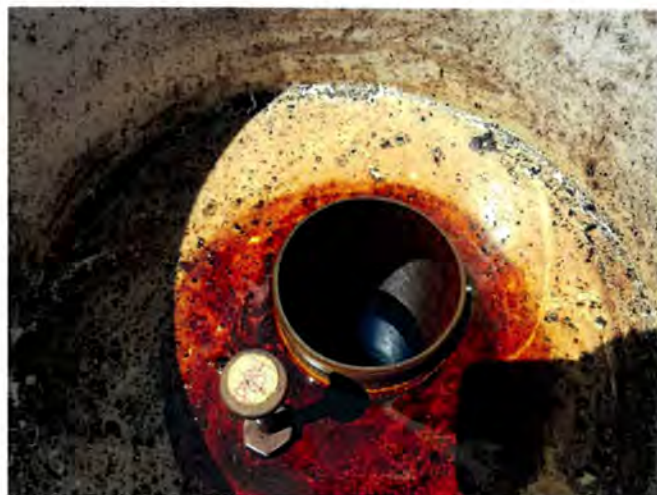
fuel level in stand-pipe

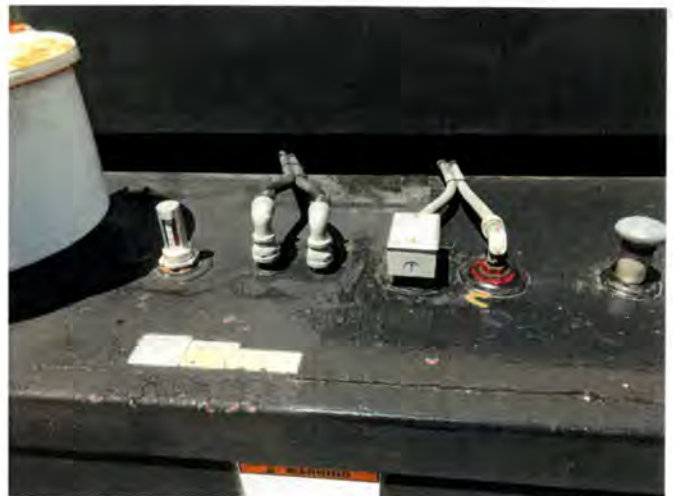
possible high level switch/not marked

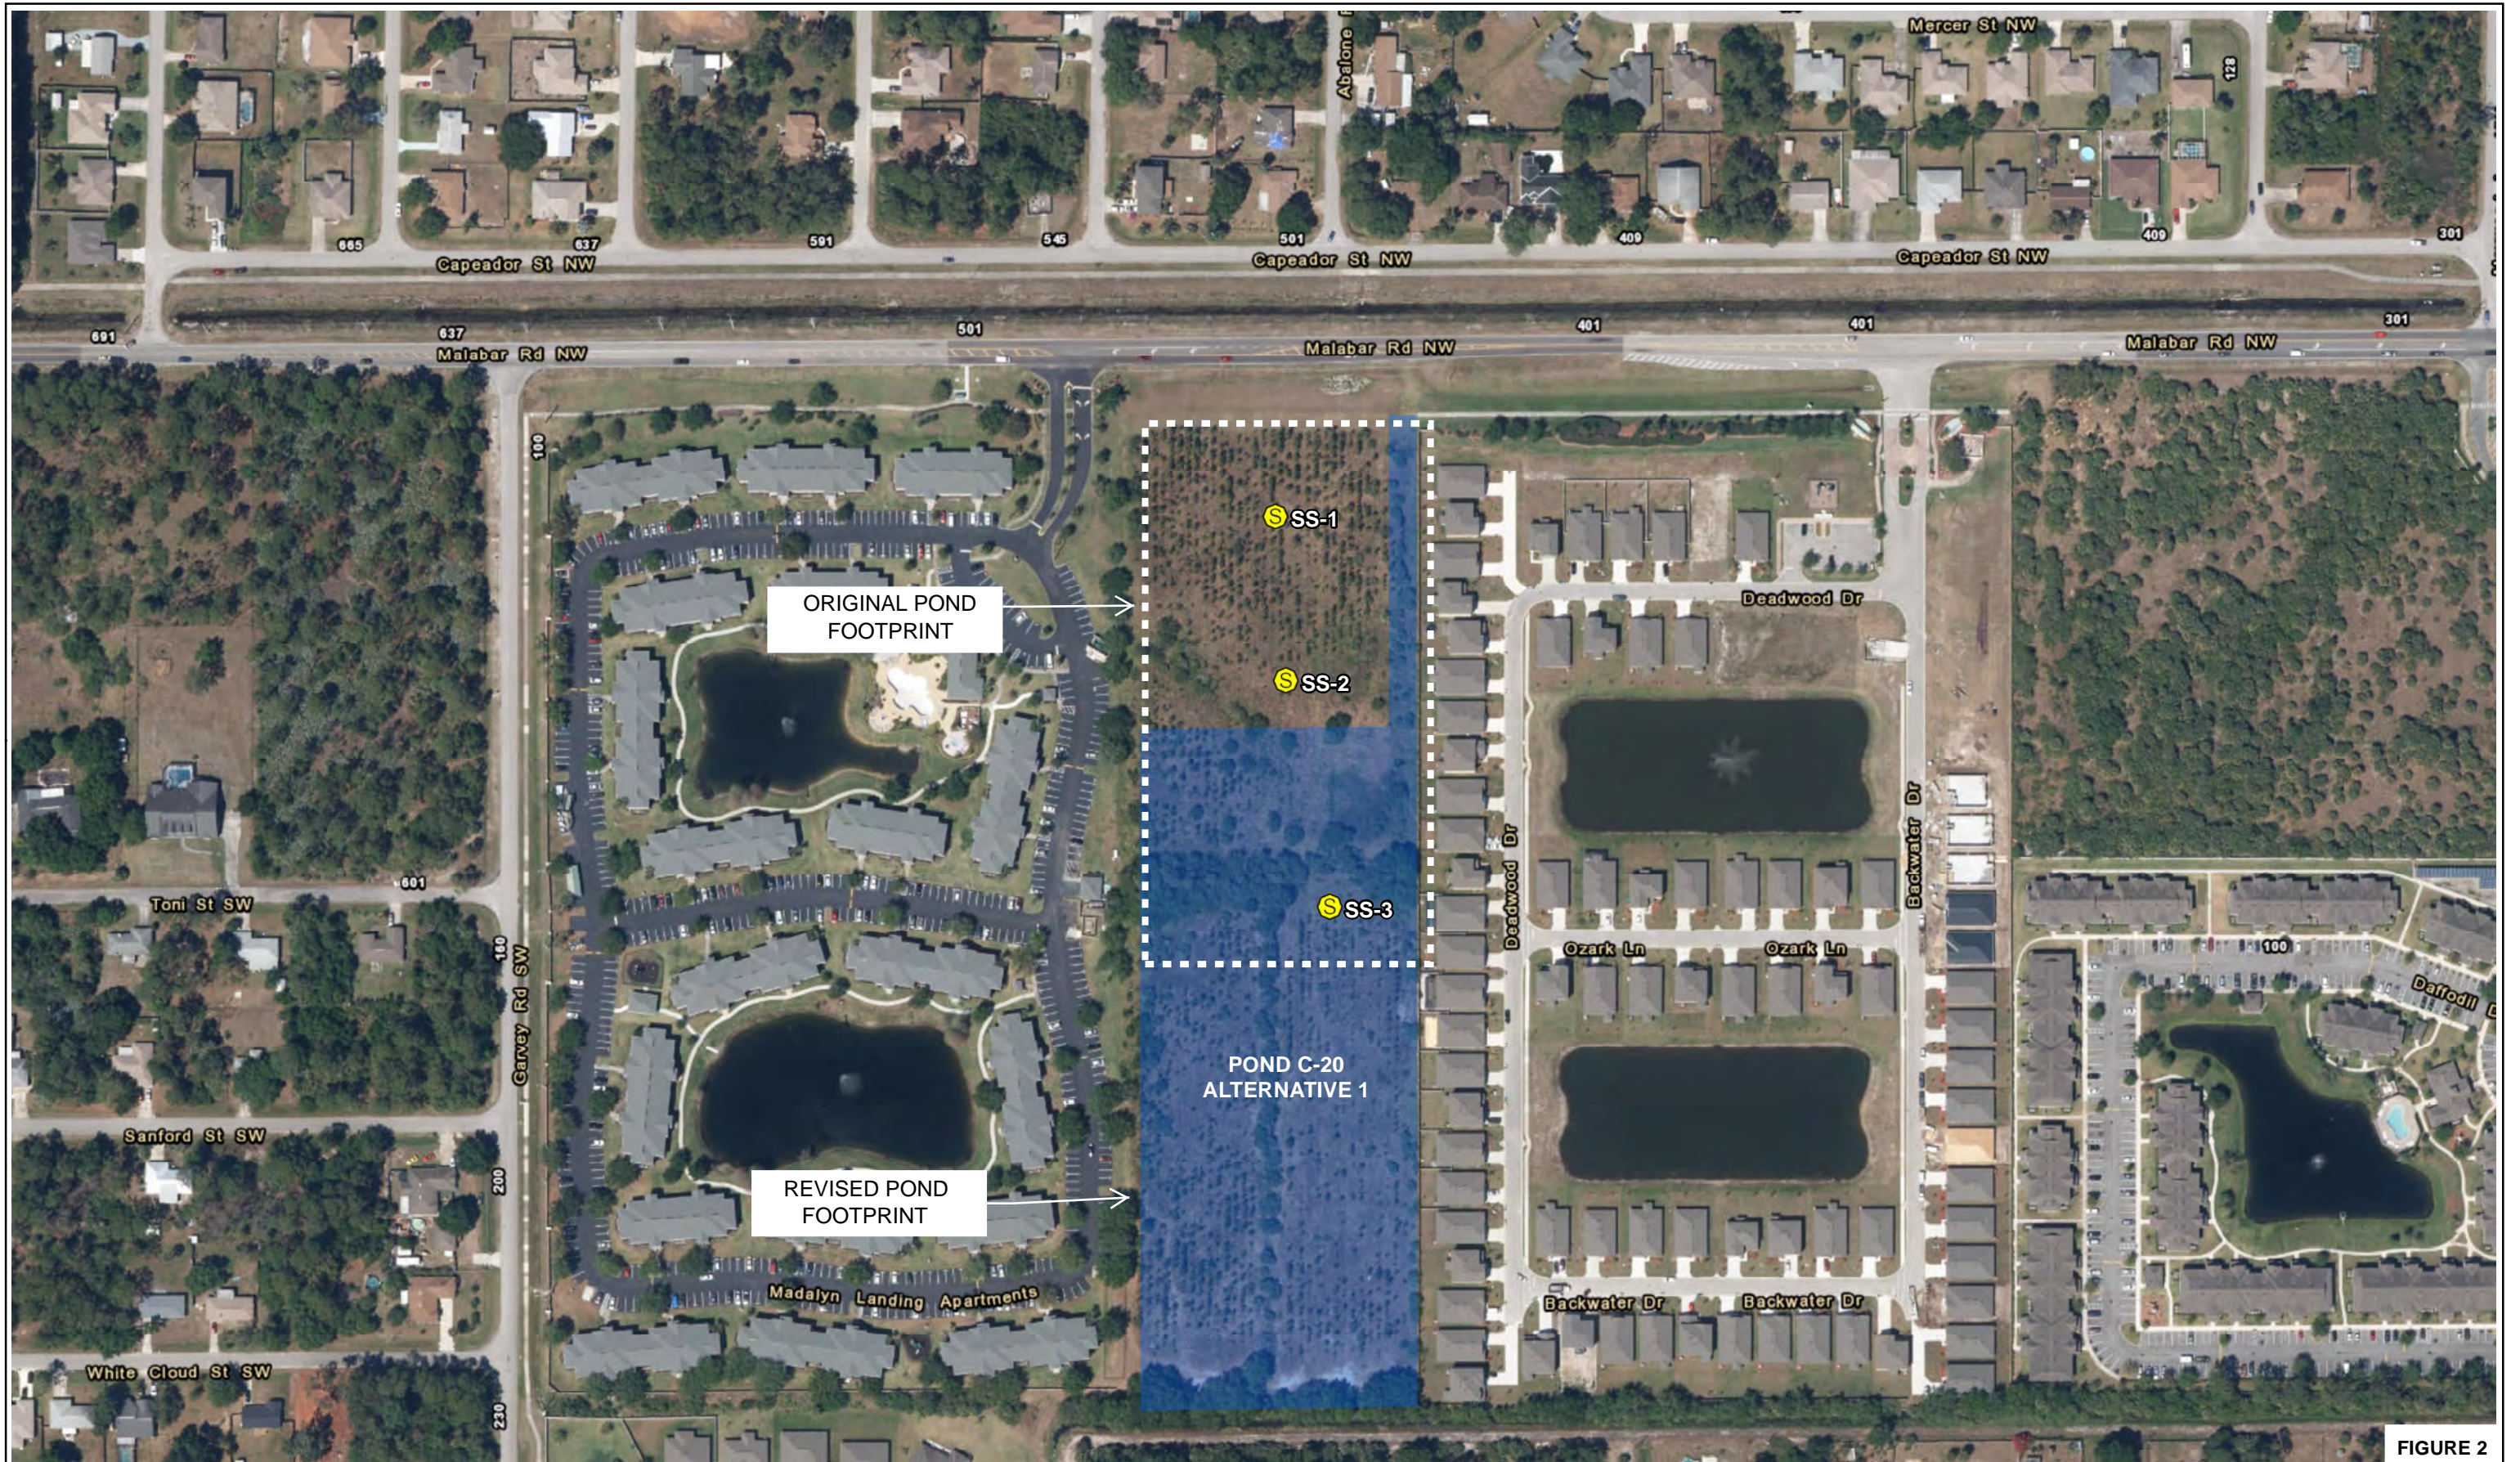
FIGURE 2

APPROXIMATE SOIL SAMPLING LOCATION
